# Function and Use of a Nineteenth-Century Barn: "Walnut Hill" Estate, Pawling Road, Lower Providence Township, Montgomery County, Pennsylvania

Brooke Elin Vincent  
*University of Pennsylvania*

Vincent, Brooke Elin (1991). *Function and Use of a Nineteenth-Century Barn: "Walnut Hill" Estate, Pawling Road, Lower Providence Township, Montgomery County, Pennsylvania*. (Masters Thesis). University of Pennsylvania, Philadelphia, PA.

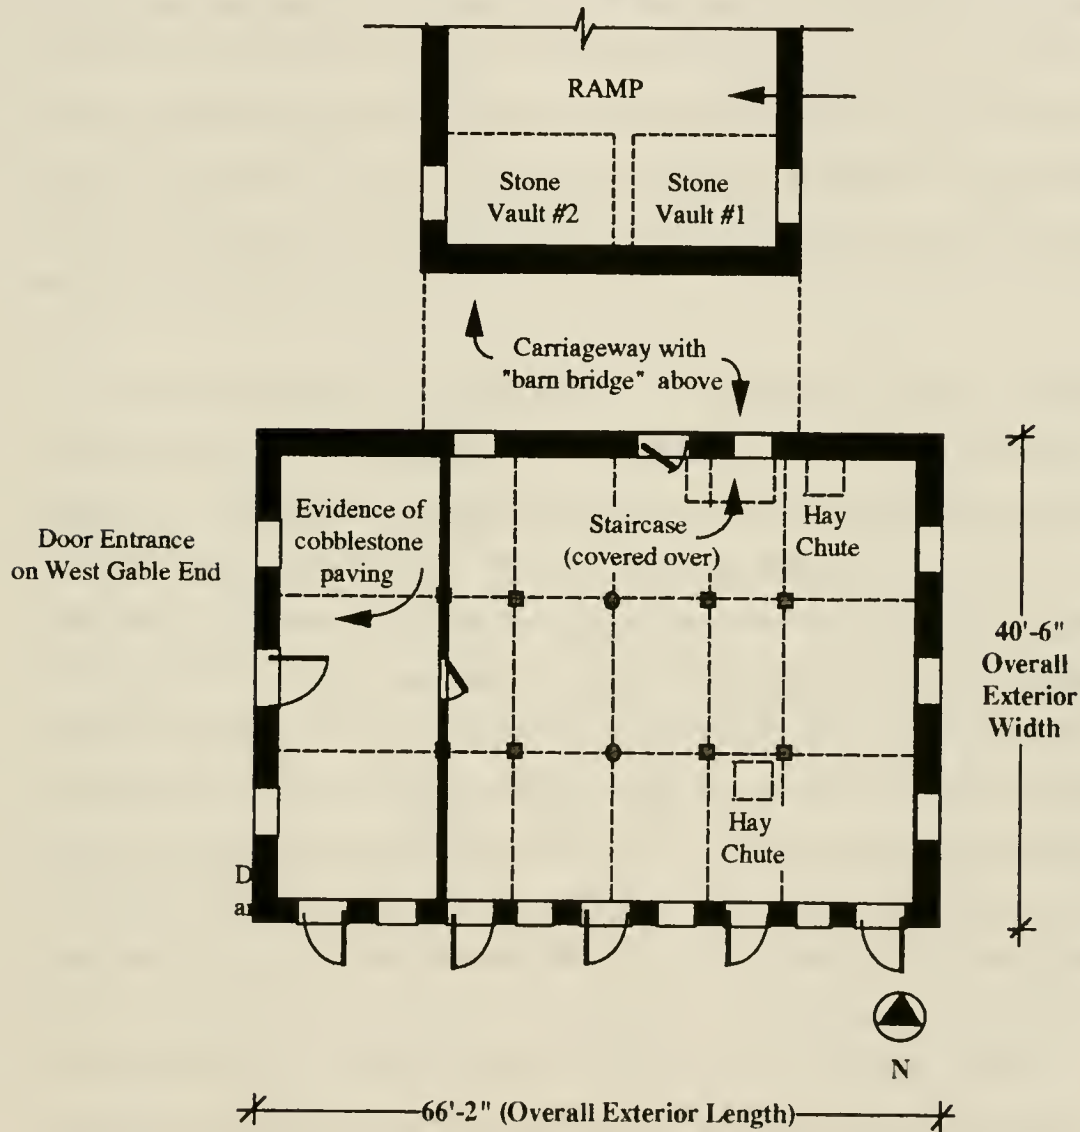
**Figure 11:** 1826 Ground Floor Plan of Walnut Hill barn (not to scale)

The interior arrangement of the 1826 barn consisted of stables at the lower basement level, grain storage at the middle level, and the threshing platform and hay mows at the third level. The stables were sheltered on the north side by the bank and, most likely, opened to an enclosed farmyard along the south elevation. This open corral served as a place to exercise and water the animals, and collect their dung. As cited in the previous chapter on Pennsylvania barns, John Nicholson, an early writer on the subject of agricultural practices, recommended the construction of a high fence to enclose a section of the barnyard. The ground should slope slightly, with the lowest area in the middle to collect the manure, which could then be spread on the fields as fertilizer. Nicholson also mentioned that a well should be nearby to supply water for the cattle.<sup>15</sup>

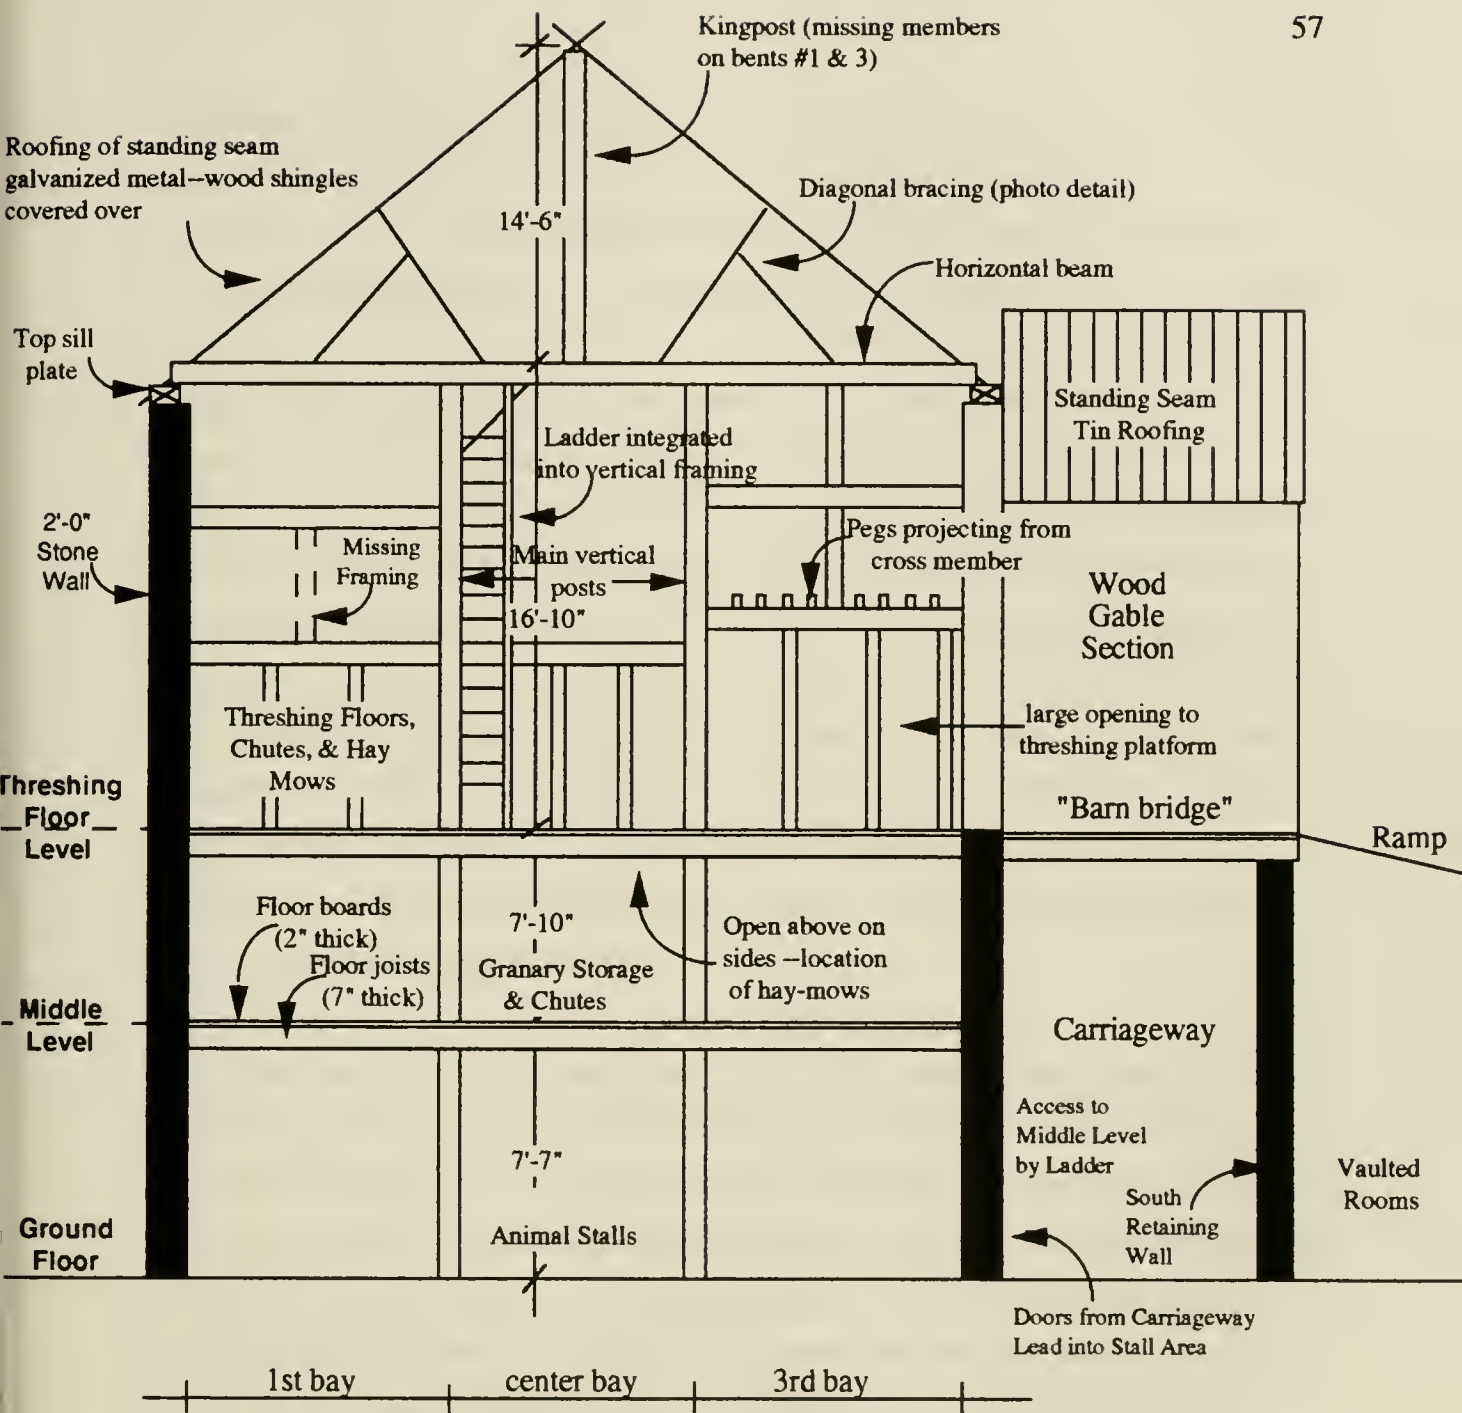
**Figure: 13** 1826 Section of Walnut Hill barn showing cross section of typical bent (not to scale)

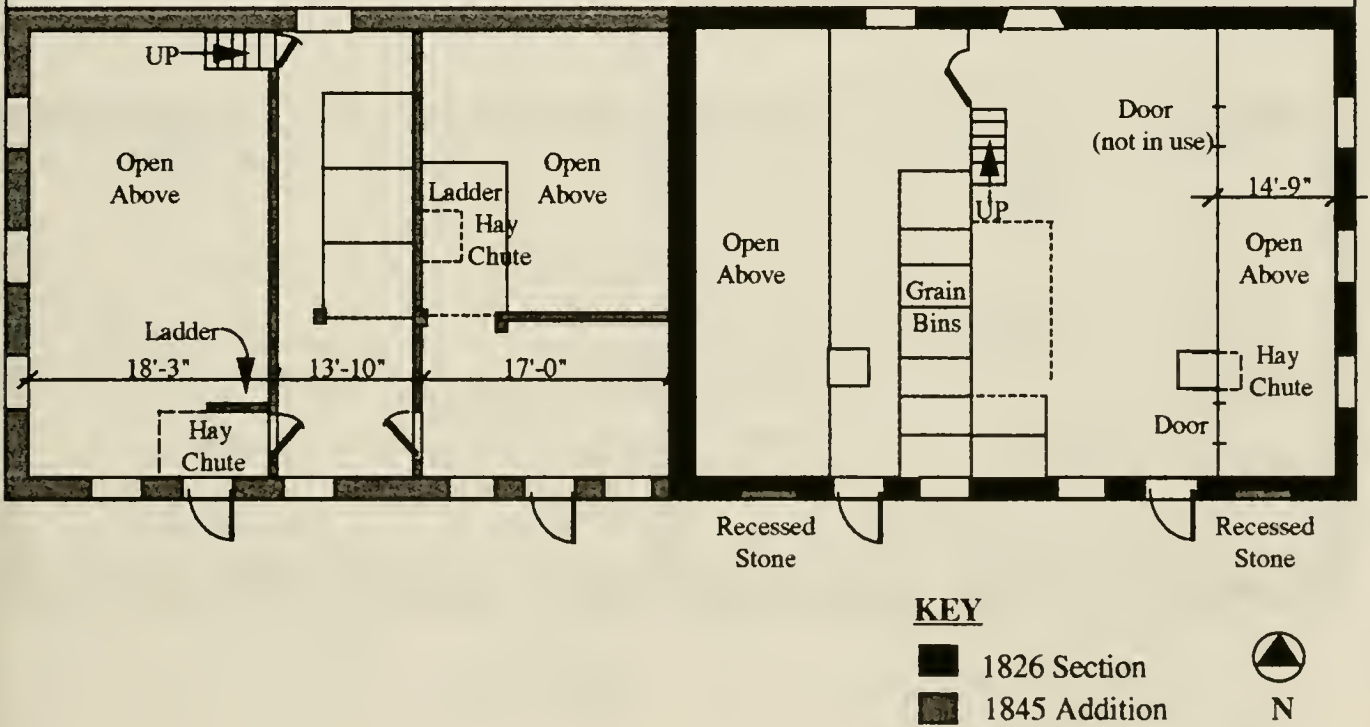
**Figure 16:** Middle Level, or Granary, of Walnut Hill barn (not to scale)

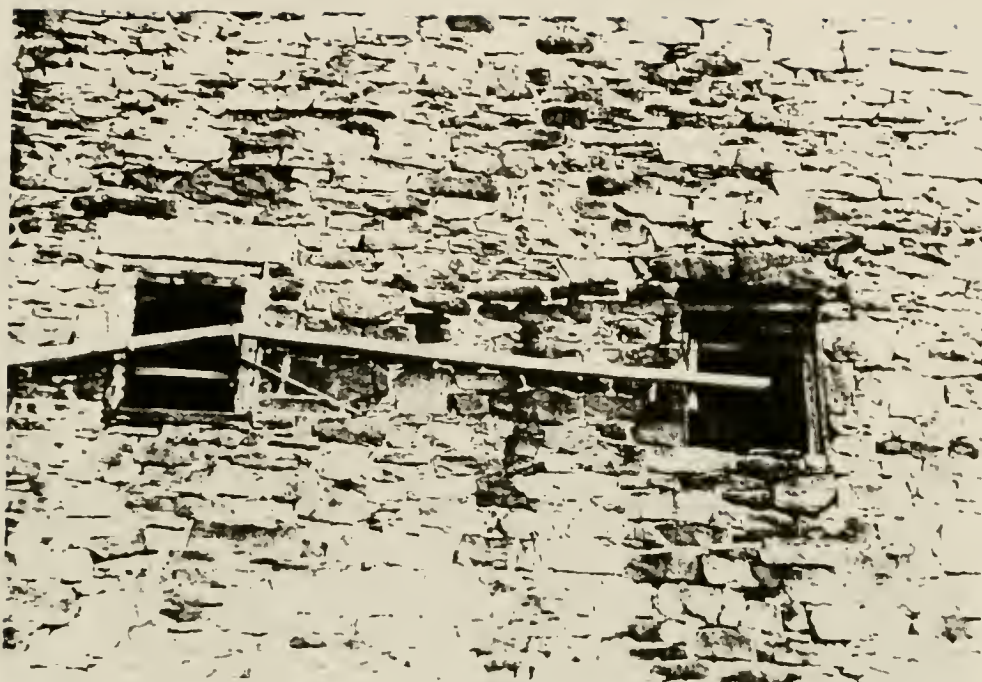
**Plate 19:** Detail of west gable end windows showing bluestone lintel (left) and sandstone rubble support (right)

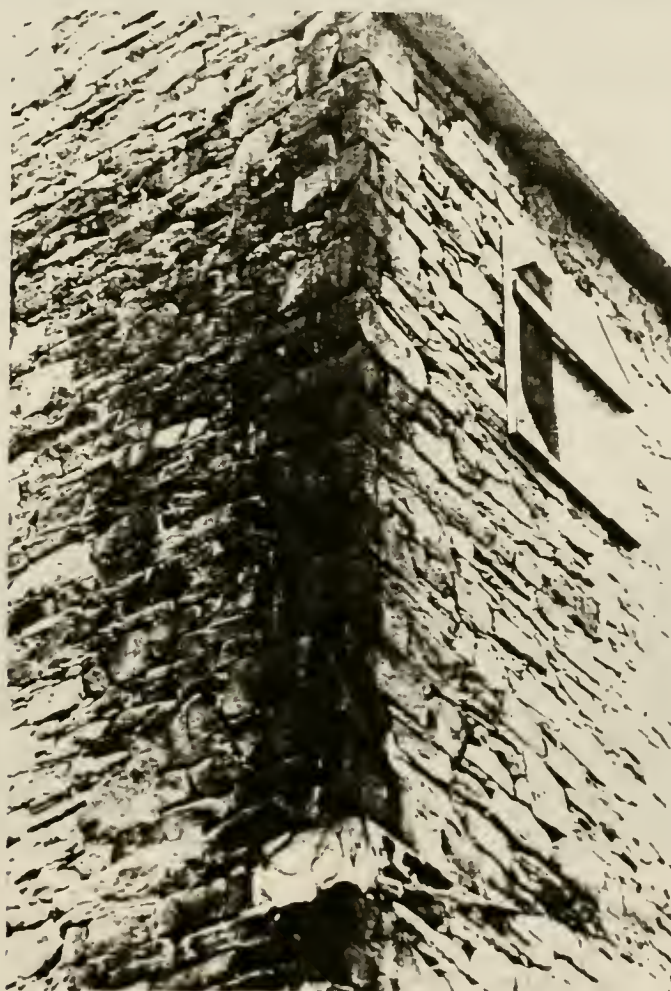
**Plate 20:** Detail of corner quoins along southwest edge of barn

upper gable portion. Stone quoins define the edges (Plate 20). Bluestone lintels are found on the first and second floor windows, as well as the center window on the third floor. The ridge pointing is still partially visible on this facade, although suffering an advanced state of deterioration.

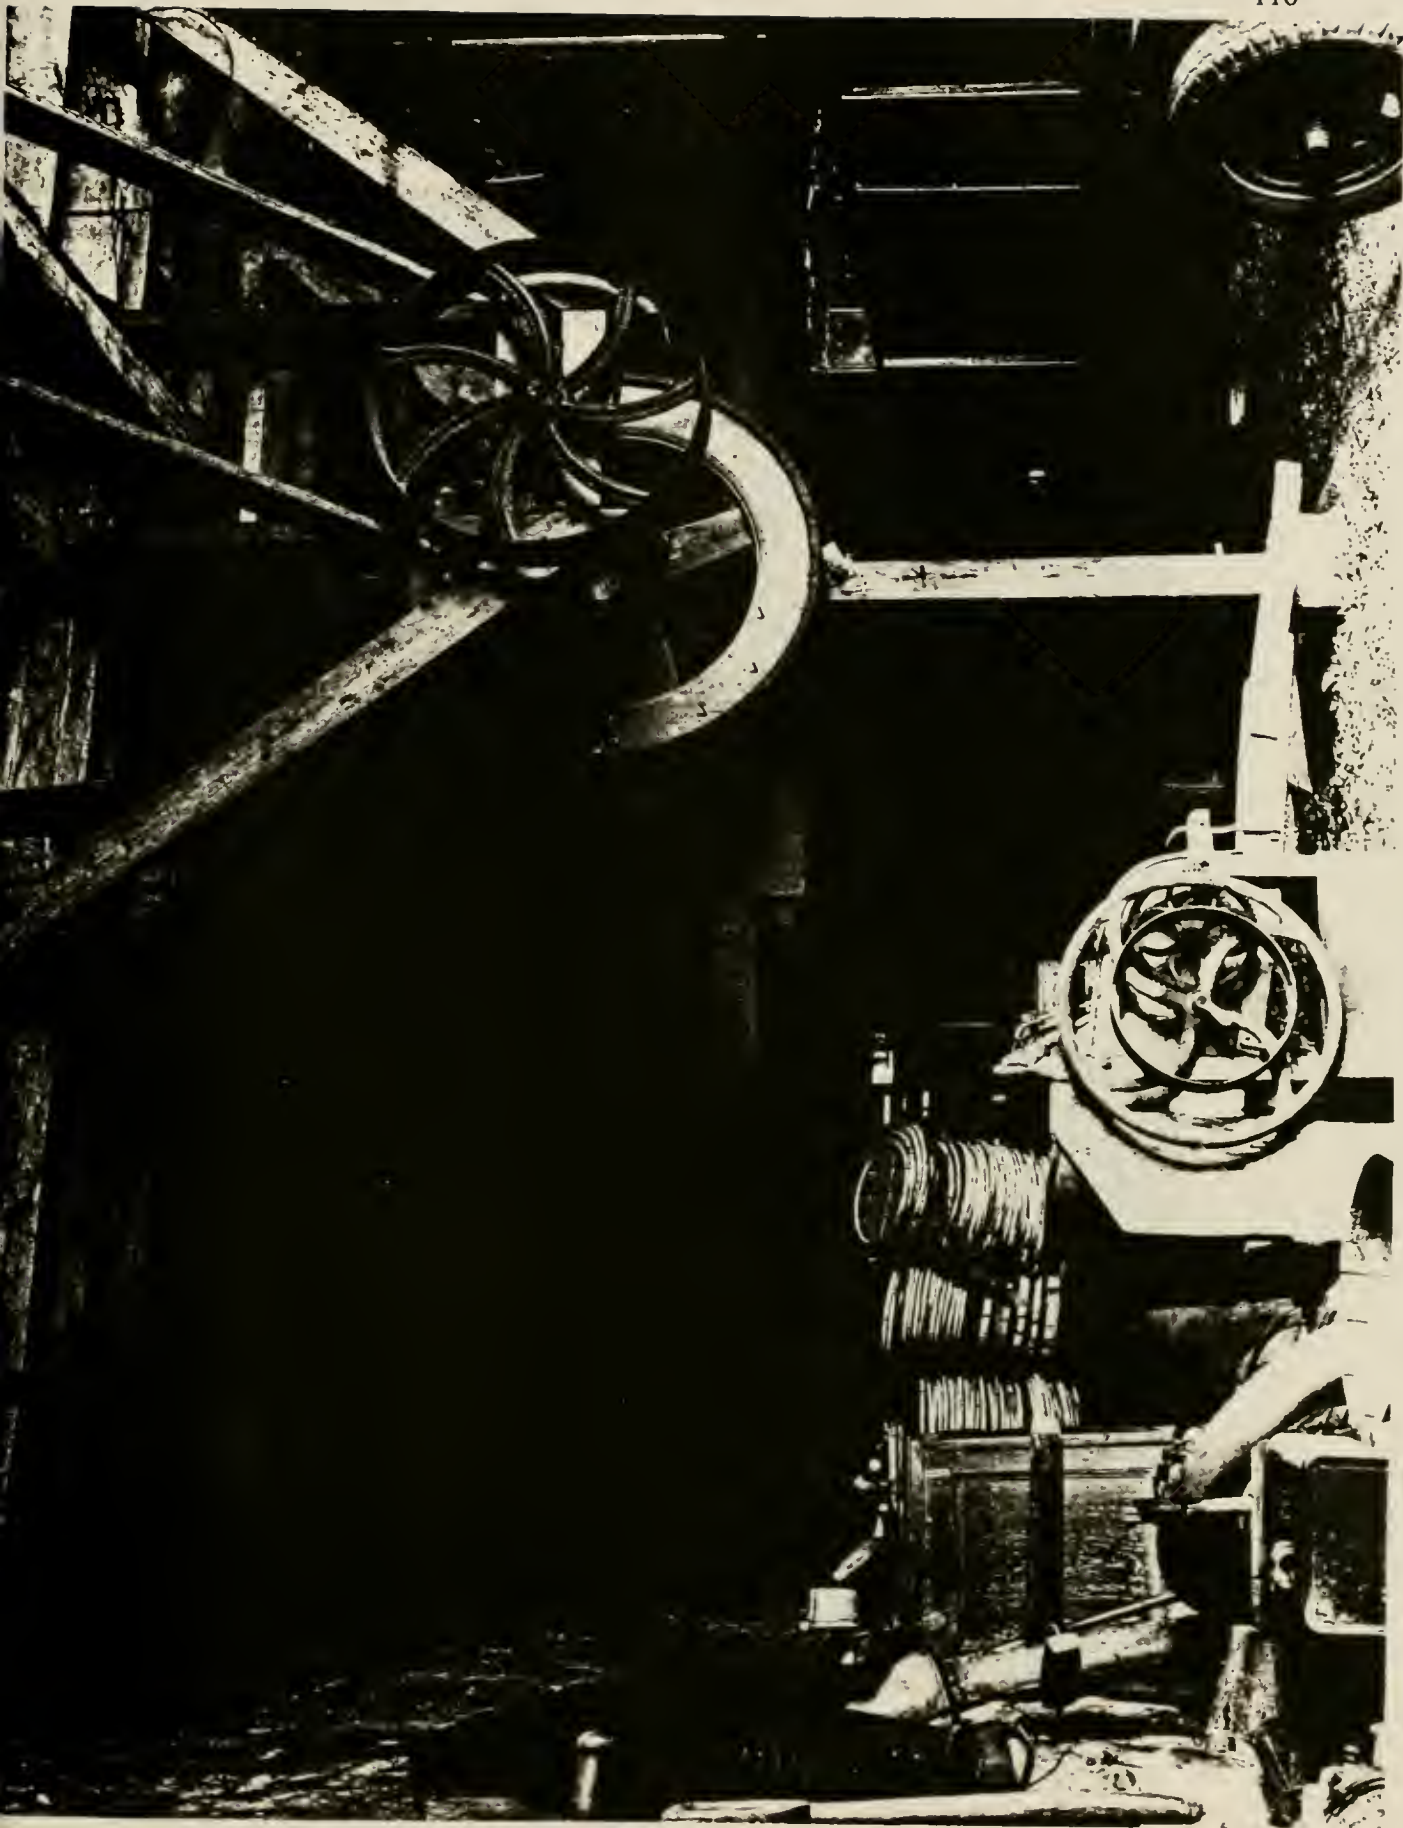
**Plate 57:** 1845 carriageway looking east, showing machinery setup, taken in 1940s. H.A.B.S. #PA-5350-4 (Washington, D.C.: Library of Congress)

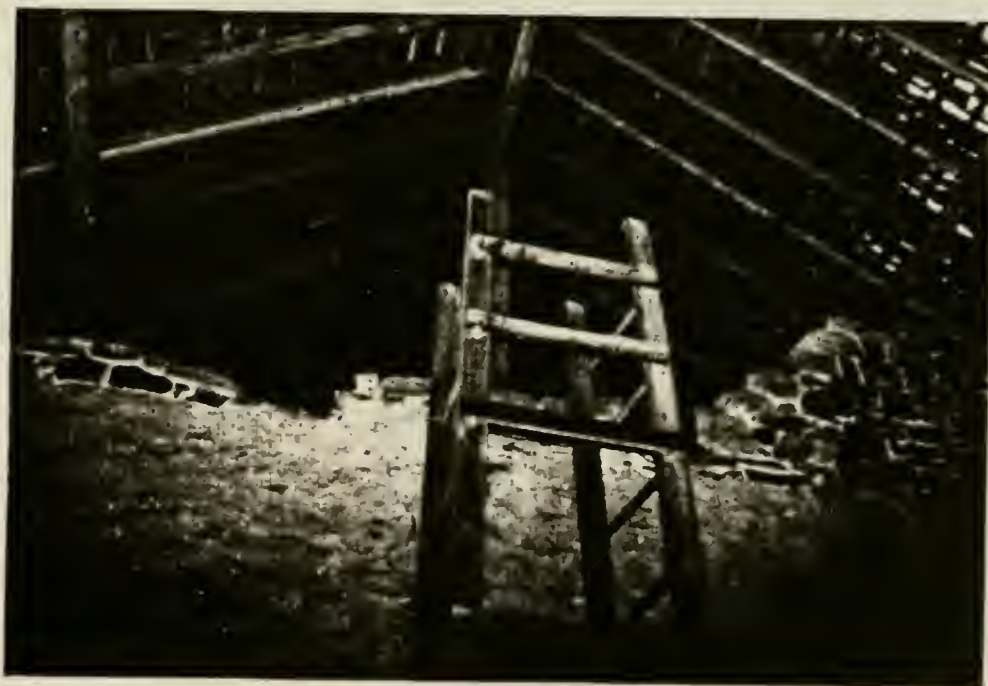
**Plate 72:** Close-up of ventilator poles. Note broken section of original west gable end
